Marco Island Home Inspection

Home Inspection Report

March 1, 2012

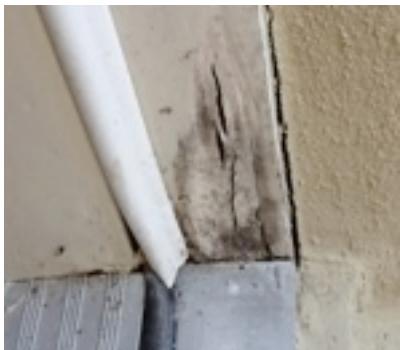
There was a two (2) car garage with a concrete floor. The electric garage door opener was manufactured by Lift Master 3/4 h.p. The garage door opener was operational. There is automatic safety reverse on the door which was operational. The lighting was operational. **There is minor wood rot and water staining just above the threshold about three inches. There is one fluorescent light fixture that did not come on.**
